**Flood Control Project Maintenance
Levee Inspections**

Fall 2018 Levee Maintenance Deficiency Summary Report

San Joaquin River Basin

Reclamation District No. 0017 Mossdale

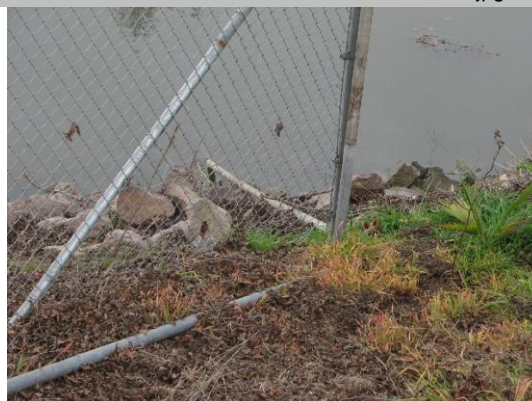
Photo 3 of 3 : UCIP_FA_2018_43264_72123.jpg

Comment Code						
Inspector Comment						
FS_ID:43264 DS_ID:28 EP_NO: 15111 Repair Type: Non-Urgent Crossing Status: Found UCIP Comments: 2/4/15--Olivia 2010 Records from KSN show this crossing was removed based on the RD17 As-Built Pipe Crossing Stationing Reference, however when field verification was completed in this area a 2-inch pipe was found. This could be a different 2-inch pipe in nearby area. Need to coordinate with owner to determine permit issued for this crossing.2/4/10 Pipe is not continous. Need to coordinate with owner to determine status of crossing. If crossing is no longer in use owner will need to contact the CVFPB to comply with Title 23. FIELD_STRUCT_DESC: *REMOVED* 2-inch pipeline through levee, 3.92 feet (invert depth) below levee crown. Siphon breaker on landside (LS) shoulder. Pump on waterside (WS) slope. Pipe extends beyond 10 feet of the LS toe. (existing 2-inch removed under Permit No. 15111, 1990 - R. Jocopetti; 2-inch pipe was removed during the levee work approved under Permit No. 15014, 1989 - Reclamation District 17 [RD0017]) [Additional Reference(s): DWR Levee Logs, 1981, 2003] FS Date: 2/4/2010

View of crossing on waterward side.

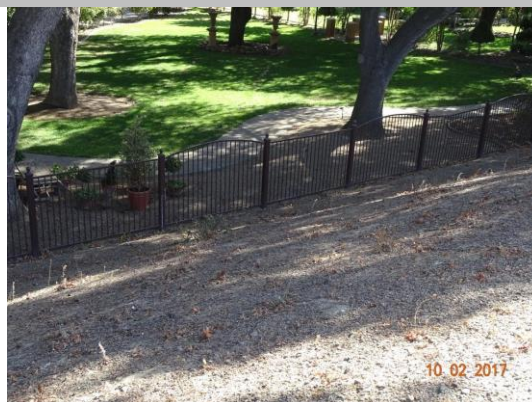
Photo 1 of 1 : FA_2018_RD0017_304_79_20180906_00014.jpg

LM Start	4.23	Rating **	M	Issue No.	79
LM End	4.28	Issue Type +	En	Location *	LS
Category	Earthen Levee			GPS Latitude/Longitude	
				Start	End
Item	Encroachments			37.863494 °	37.862935 °
				-121.320158 °	-121.319798 °
DWR ID	DWR_RD0017_02_f_2017_79				
Comment Code					
FE : Fence					
Inspector Comment					
Fence along landside toe limiting access.

Looking east at the landside slope.

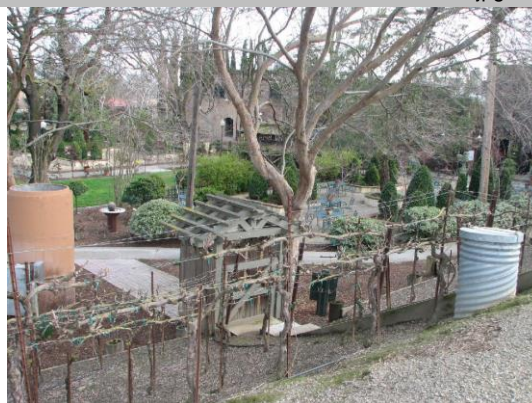
Photo 1 of 3 : UCIP_FA_2018_40662_72130.jpg

Comment Code					
Inspector Comment					
FS_ID:40662 DS_ID:29 EP_NO: 15112 Repair Type: Non-Urgent Crossing Status: Found UCIP Comments: Need to coordinate with owner to determine status of crossing. If crossing is no longer in use owner will need to contact the CVFPB to comply with Title 23. Debris (pipe section) scattered on waterward side. FIELD_STRUCT_DESC: 10-inch steel irrigation pipe through levee, 3.29 feet below crown. Siphon breaker on landside (LS) shoulder. Pump on waterside (WS) berm, standpipe located 28 feet from the LS toe. Stairway located on both WS and LS slopes. (10-inch pipe installed and existing 10-inch pipe removed under Permit No. 15112, 1990 - C. Marshall; 10-inch pipe was installed during the levee work approved under Permit No. 15014, 1989 - Reclamation District 17 [RD0017]) [Additional Reference(s): DWR Levee Logs, 1981 and 2003] FS Date: 2/4/2010

View of landward side.

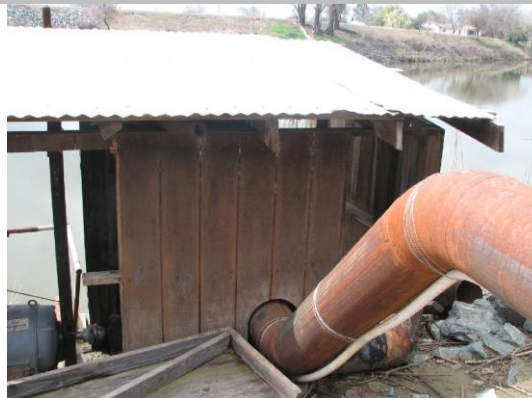
Photo 3 of 3 : UCIP_FA_2018_40662_72134.jpg

Comment Code						
Inspector Comment						
FS_ID:40662 DS_ID:29 EP_NO: 15112 Repair Type: Non-Urgent Crossing Status: Found UCIP Comments: Need to coordinate with owner to determine status of crossing. If crossing is no longer in use owner will need to contact the CVFPB to comply with Title 23. Debris (pipe section) scattered on waterward side. FIELD_STRUCT_DESC: 10-inch steel irrigation pipe through levee, 3.29 feet below crown. Siphon breaker on landside (LS) shoulder. Pump on waterside (WS) berm, standpipe located 28 feet from the LS toe. Stairway located on both WS and LS slopes. (10-inch pipe installed and existing 10-inch pipe removed under Permit No. 15112, 1990 - C. Marshall; 10-inch pipe was installed during the levee work approved under Permit No. 15014, 1989 - Reclamation District 17 [RD0017]) [Additional Reference(s): DWR Levee Logs, 1981 and 2003] FS Date: 2/4/2010

Pipe through pump house located on waterward side.

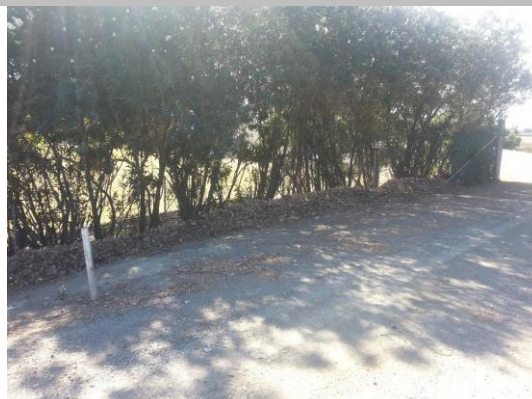
Photo 1 of 2 : FA_2018_RD0017_304_1_20180906_00001.jpg

LM Start	4.37	Rating **	A/W	Issue No.	1
LM End	4.39	Issue Type +	En	Location *	LS
Category	Earthen Levee			GPS Latitude/Longitude	
				Start	End
Item	Vegetation			37.861673 °	37.861370 °
				-121.320115 °	-121.320102 °
DWR ID	DWR_RD0017_02_s_2012_1				
Comment Code					
V6 : Landscaping					
Inspector Comment					
Oleander along fence line. LMA trimmed oleander along landside.

Looking south at trimmed oleanders on landward slope along fence.

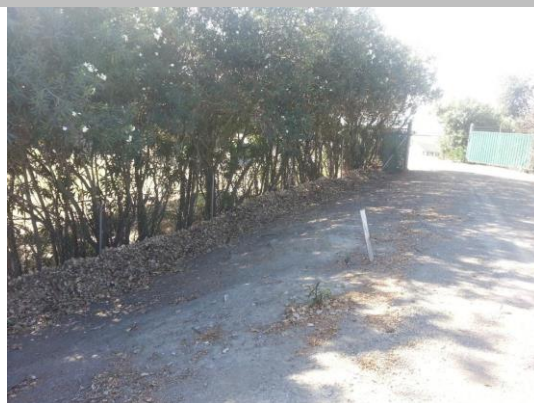
Photo 2 of 2 : FA_2018_RD0017_304_1_20180906_00002.jpg

LM Start	4.37	Rating **	A/W	Issue No.	1 (cont)	
LM End	4.39	Issue Type +	En	Location *	LS	
Category	Earthen Levee			GPS Latitude/Longitude		
				Start		End
Item	Vegetation			37.861673 °	37.861370 °	
				-121.320115 °	-121.320102 °	
DWR ID	DWR_RD0017_02_s_2012_1					
Comment Code						
V6 : Landscaping						
Inspector Comment						
Oleander along fence line. LMA trimmed oleander along landside.

Looking southwest at trimmed oleanders on landward slope along fence.

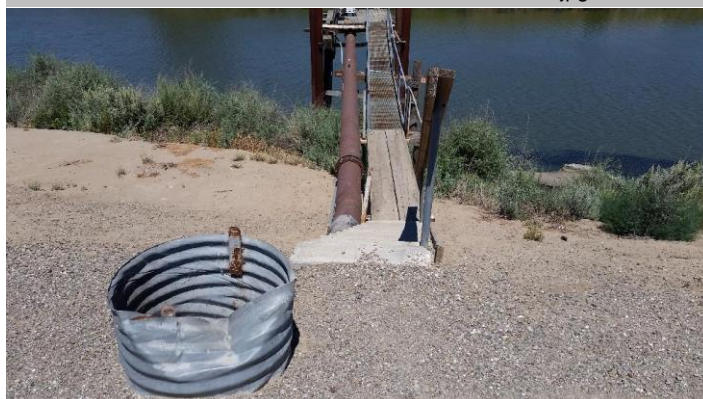
Photo 1 of 3 : UCIP_FA_2018_53330_75723.jpg

UCIP Comments: 9/5/2018 WS slope severe erosion appears to have been fixed somewhat, however, some erosion still present. Massive LS slippage and sink hole present. Notified LMA Engineer, DWR Inspector, and CVFPB Enforcement. Recommend monitoring of site through flood season, and remains Urgent until full inspection of site (D. Sanoski - DWR UCIP).12/01/2017 Inspection update is based on supporting documentation provided by KSN Inc, R. Toy, on November 18, 2016. Levee slope repair was performed on the LS slope area. Crossing remains Urgent--internal erosion visible from WS where pipe daylights has not been addressed. Recommend internal inspection of pipe through the levee to determine pipe condition. (DWR UCIP - o. magana) 7/12/2016 Same as last inspection--internal erosion on WS and LS slope slipping with visible head scarp. Internal erosion visible from WS where pipe daylights. LS slope slipping with visible head scarp approximately 6-inches. Need to coordinate with owner to address issue. Owner will need to work with DWR Inspector and CVFPB to comply with Title 23 requirements. Recommend internal integrity inspection of crossing to determine pipe condition through levee. (DWR UCIP - omagana)5/19/2015 Signs of internal erosion visible on waterward side where pipe daylights. Slope slumping visible on landward side where previous levee damage was present. Need to contact owner and KSN, LMA engineering firm, to coordinate potential issues with pipe. (DWR UCIP - omagana)2/04/2010 Pipe failure--internal erosion visible on waterward and landward side. Recommend LMA superintendent notify owner to stop using crossing to avoid further damage to levee slope. Owner will need to coordinate with DWR Inspector and CVFPB to address pipe failure per Title 23 requirements. (DWR UCIP - omagana)

FIELD_STRUCT_DESC: 14-inch steel irrigation pipe through levee, 3.66-feet below the levee crown. Siphon breaker is located on the waterside (WS) shoulder. Also visible on the WS is the pump, the platform supported by steel piles in channel, a wooden walkway which extends from pump platform to WS slope, a concrete stairway which extends from walkway to WS shoulder. A double side approach ramp is located on the landside (LS) slope. (14-inch installed and existing 12-inch pipe removed under Permit No. 15116, 1990 - Rio Blanco Ranch, Inc.; 14-inch pipe was installed as part of the re-shaping of RD17 project levees in 1989. The re-shaping of the levees was to increase levee elevations and provide freeboard above 100-year stages in both the San Joaquin River and French Camp Slough; work was authorized and documented under Permit No. 15014, 1989 - Reclamation District [RD0017]) [Additional Reference(s): DWR Levee Log, 1981 and 2003]

View of WS.

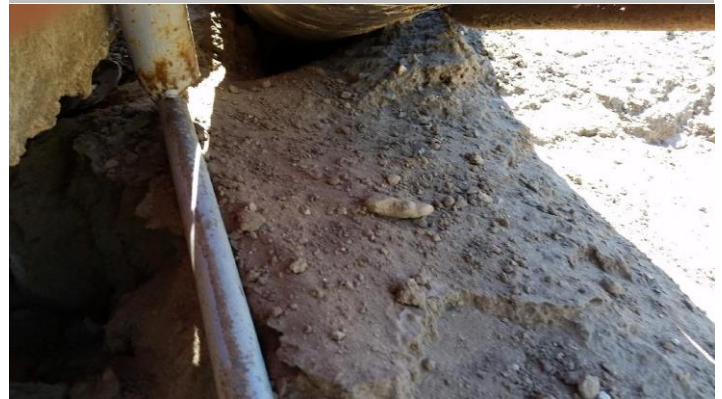
Photo 2 of 3 : UCIP_FA_2018_53330_75724.jpg

Internal erosion still visible on WS.

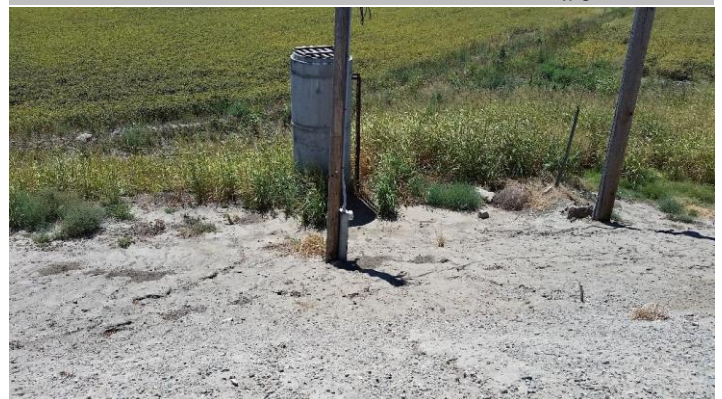
Photo 3 of 3 : UCIP_FA_2018_53330_75720.jpg

View of LS.

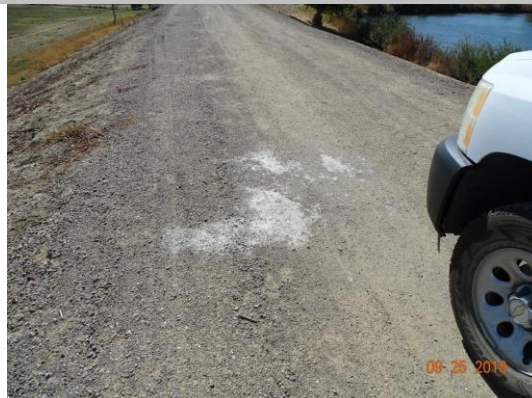
Photo 1 of 2 : FA_2018_RD0017_304_82_20180927_00201.jpg

Looking south at typical view of grouted rodent holes on landward shoulder. (Fall 2018)

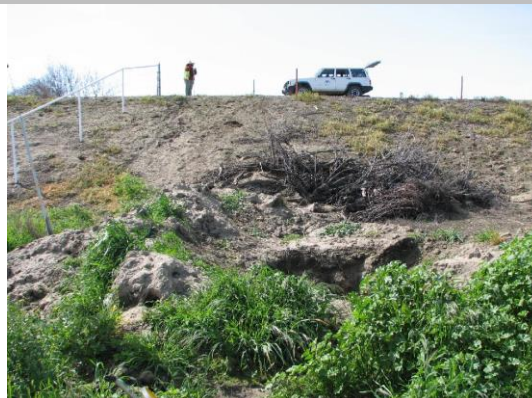
Photo 1 of 3 : UCIP_FA_2018_52587_72215.jpg

FS_ID:52587
DS_ID:34
EP_NO: 15117
Repair Type: Non-Urgent
Crossing Status: Found
UCIP Comments: 12/01/2017 Supporting documentation (field report) was received from KSN, Inc, R. Toy, addressing the repair of the leaking pipe and levee slope at this location. Compaction tests associated with the repair have not been received -- need to coordinate with CVFPB, LMA, and DWR Inspector. (DWR UCIP - O. Magana)07/12/2016 Crossing has been downgraded from Urgent to Non-Urgent--LS levee slope repaired. Levee slope was disturbed to repair leaky pipe--LS splice approximately 20-30 feet off the LS toe. Need to contact owner to determine if any documentation is available to support repair extent or internal integrity inspection of pipe through levee. (DWR UCIP - omagana)02/04/2010 Section of landward slope exposed--Need to contact owner to address cut on levee and determine status of crossing. Dense vegetation limits the inspector's visibility to identify signs of pipe failure (leaks) along the slope. Recommend removing vegetation along pipe alignment to conduct proper inspection of structure. (DWR UCIP - omagana)

View of LS.

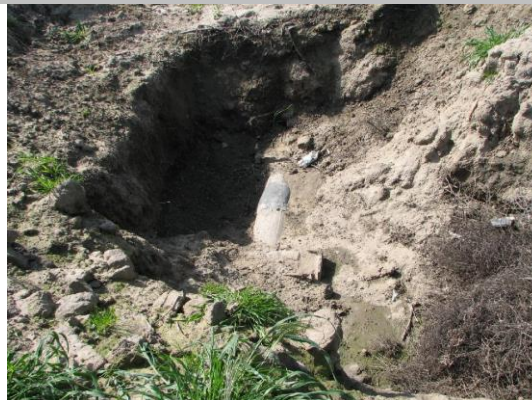
Photo 2 of 3 : UCIP_FA_2018_52587_72214.jpg

Comment Code						
Inspector Comment						
FS_ID:52587						
DS_ID:34						
EP_NO: 15117						
Repair Type: Non-Urgent						
Crossing Status: Found						
UCIP Comments: 12/01/2017 Supporting documentation (field report) was received from KSN, Inc, R. Toy, addressing the repair of the leaking pipe and levee slope at this location. Compaction tests associated with the repair have not been received -- need to coordinate with CVFPB, LMA, and DWR Inspector. (DWR UCIP - O. Magana)07/12/2016 Crossing has been downgraded from Urgent to Non-Urgent--LS levee slope repaired. Levee slope was disturbed to repair leaky pipe--LS splice approximately 20-30 feet off the LS toe. Need to contact owner to determine if any documentation is available to support repair extent or internal integrity inspection of pipe through levee. (DWR UCIP - omagana)02/04/2010 Section of landward slope exposed--Need to contact owner to address cut on levee and determine status of crossing. Dense vegetation limits the inspector's visibility to identify signs of pipe failure (leaks) along the slope. Recommend removing vegetation along pipe alignment to conduct proper inspection of structure. (DWR UCIP - omagana)

Section of levee slope exposed on LS.

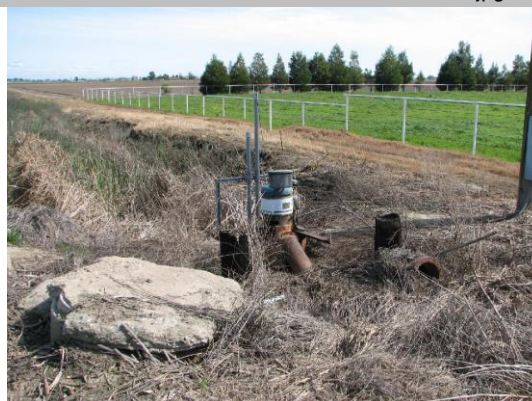
Photo 3 of 3 : UCIP_FA_2018_52587_72213.jpg

FS_ID:52587
DS_ID:34
EP_NO: 15117
Repair Type: Non-Urgent
Crossing Status: Found
UCIP Comments: 12/01/2017 Supporting documentation (field report) was received from KSN, Inc. R. Toy, addressing the repair of the leaking pipe and levee slope at this location. Compaction tests associated with the repair have not been received -- need to coordinate with CVFPB, LMA, and DWR Inspector. (DWR UCIP - O. Magana)07/12/2016 Crossing has been downgraded from Urgent to Non-Urgent--LS levee slope repaired. Levee slope was disturbed to repair leaky pipe--LS splice approximately 20-30 feet off the LS toe. Need to contact owner to determine if any documentation is available to support repair extent or internal integrity inspection of pipe through levee. (DWR UCIP - omagana)02/04/2010 Section of landward slope exposed--Need to contact owner to address cut on levee and determine status of crossing. Dense vegetation limits the inspector's visibility to identify signs of pipe failure (leaks) along the slope. Recommend removing vegetation along pipe alignment to conduct proper inspection of structure. (DWR UCIP - omagana)

Pump station located on LS toe.

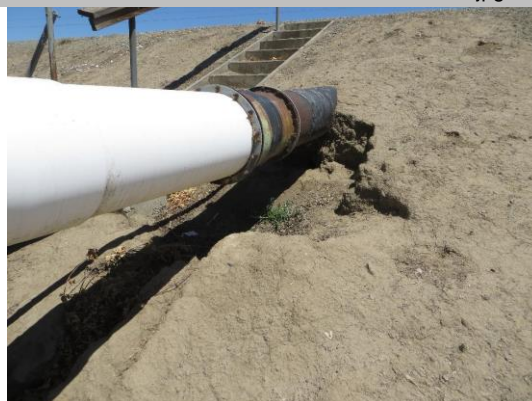
Photo 1 of 3 : UCIP_FA_2018_45998_74483.jpg

Comment Code						
Inspector Comment						
FS_ID:45998						
DS_ID:35						
EP_NO: 15118						
Repair Type: Non-Urgent						
Crossing Status: Found						
UCIP Comments: 05/19/2015 Erosion is still present on waterward side--wet soil along pipe alignment (where pipe seciton is exposed). Burrow activity is also present at this location. Recommend contacting owner to address burrow activity. 02/04/2010 Erosion visible on waterward side visible at pipe daylight. Need to contact owner to address potential pipe failure. Need to determine status of crossing.						
FIELD_STRUCT_DESC: 14-inch steel irrigation pipe through levee, 3.32 feet below levee crown. Siphon breaker on landside (LS) shoulder. Pump on platform in channel, wooden walkway extends from pump platform to waterside (WS) slope, concrete stairway extends from walkway to WS shoulder and a standpipe is located 2 feet from the LS toe. (14-inch pipe installed and existing 12-inch pipe removed under Permit No. 15118, 1989 - L. Matlock) [Additional Reference(s): DWR Levee Logs, 1981 and 2003]

(2015) View of waterward side--erosion at pipe daylight.

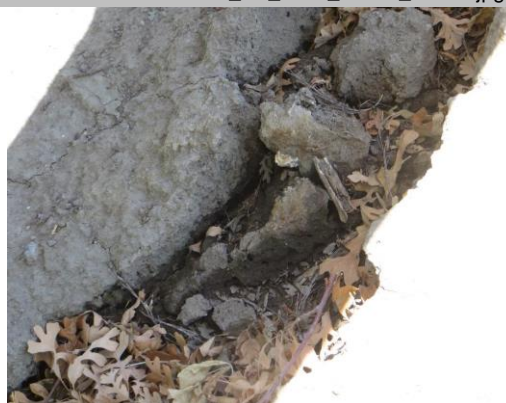
Photo 2 of 3 : UCIP_FA_2018_45998_74485.jpg

(2015) Wet ground along pipe alignment on waterward side.

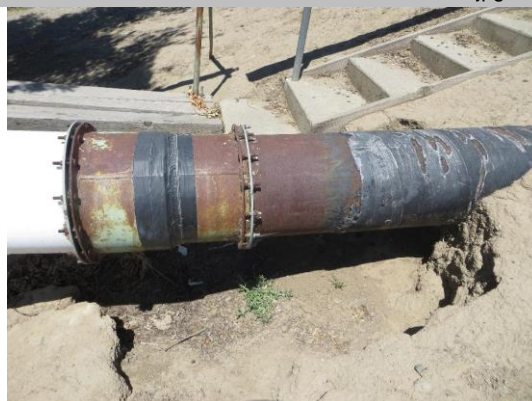
Photo 3 of 3 : UCIP_FA_2018_45998_74484.jpg

Comment Code						
Inspector Comment						
FS_ID:45998						
DS_ID:35						
EP_NO: 15118						
Repair Type: Non-Urgent						
Crossing Status: Found						
UCIP Comments: 05/19/2015 Erosion is still present on waterward side-- wet soil along pipe alignment (where pipe seciton is exposed). Burrow activity is also present at this location. Recommend contacting owner to address burrow activity. 02/04/2010 Erosion visible on waterward side visible at pipe daylight. Need to contact owner to address potential pipe failure. Need to determine status of crossing.						
FIELD_STRUCT_DESC: 14-inch steel irrigation pipe through levee, 3.32 feet below levee crown. Siphon breaker on landside (LS) shoulder. Pump on platform in channel, wooden walkway extends from pump platform to waterside (WS) slope, concrete stairway extends from walkway to WS shoulder and a standpipe is located 2 feet from the LS toe. (14-inch pipe installed and existing 12-inch pipe removed under Permit No. 15118, 1989 - L. Matlock) [Additional Reference(s): DWR Levee Logs, 1981 and 2003]

(2015) Erosion visible on waterward side.

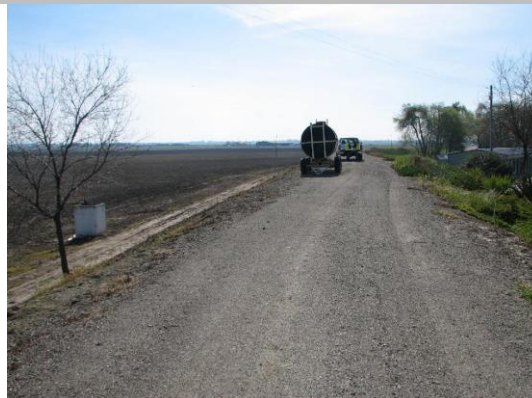
Photo 1 of 3 : UCIP_FA_2018_40669_72239.jpg

Comment Code						
Inspector Comment						
FS_ID:40669						
DS_ID:36						
EP_NO: 15119						
Repair Type: Non-Urgent						
Crossing Status: Found						
UCIP Comments: Need to contact owner to determine status.						
FIELD_STRUCT_DESC: 16-inch steel irrigation pipe through levee, 1.33 feet below levee crown. Slant pump on riverbank, standpipe located 30 feet from the landside (LS) toe. Ramp on waterside (WS) slope. (16-inch pipe authorized under Permit No. 15119, 1990 - J. J. Lawrence, et al; 16-inch pipe was part of the levee work approved under Permit No. 15014, 1990 - Reclamation District 17 [RD0017]) [Additional Reference(s): DWR Levee Logs, 1981 and 2003]						
FS Date: 2/4/2010

Overview of levee crown at crossing.

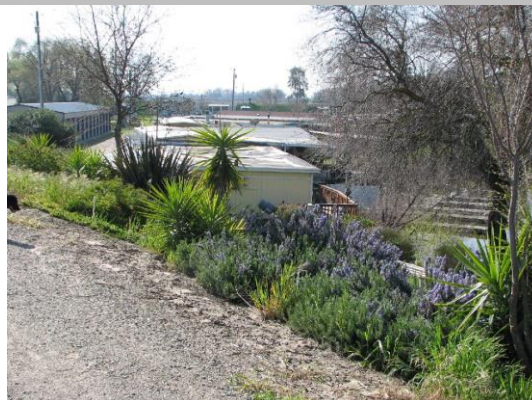
Photo 2 of 3 : UCIP_FA_2018_40669_72238.jpg

View of waterward side.

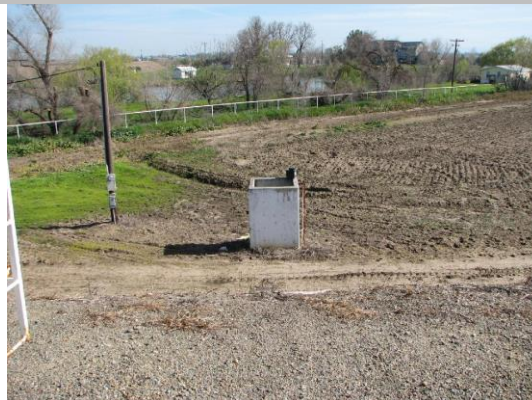
Photo 3 of 3 : UCIP_FA_2018_40669_72237.jpg

Comment Code						
Inspector Comment						
FS_ID:40669 DS_ID:36 EP_NO: 15119 Repair Type: Non-Urgent Crossing Status: Found UCIP Comments: Need to contact owner to determine status. FIELD_STRUCT_DESC: 16-inch steel irrigation pipe through levee, 1.33 feet below levee crown. Slant pump on riverbank, standpipe located 30 feet from the landside (LS) toe. Ramp on waterside (WS) slope. (16-inch pipe authorized under Permit No. 15119, 1990 - J. J. Lawrence, et al; 16-inch pipe was part of the levee work approved under Permit No. 15014, 1990 - Reclamation District 17 [RD0017]) [Additional Reference(s): DWR Levee Logs, 1981 and 2003] FS Date: 2/4/2010

Distribution box located on landward side.

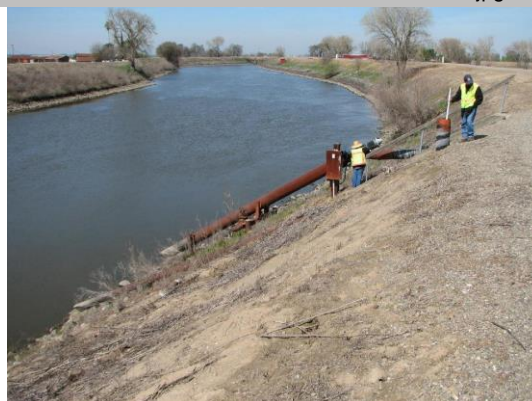
Photo 1 of 3 : UCIP_FA_2018_40672_72270.jpg

Comment Code					
Inspector Comment					
FS_ID:40672 DS_ID:38 EP_NO: 15121 Repair Type: Non-Urgent Crossing Status: Found UCIP Comments: Pipe section at waterward toe is missing wall. Need to coordinate with owner to determine integrity of pipe section through levee. This crossing is a good candidate for video inspection to determine internal condition of pipe. FIELD_STRUCT_DESC: 10-inch steel drainage through the levee, 4 feet below crown. (10-inch pipe authorized under Permit No. 15121, 1989 - R. Muller, additional work also includes removal of 12-inch and two 9-inch pipes at different locations and installation of a 12-inch pipe; 10-inch pipe was installed during the levee work approved under Permit No. 15014, 1989-Reclamation District [RD0017]) [Additional Reference(s): DWR Levee Logs, 1981 and 2003] FS Date: 2/4/2010

View of pipe section on waterward side.

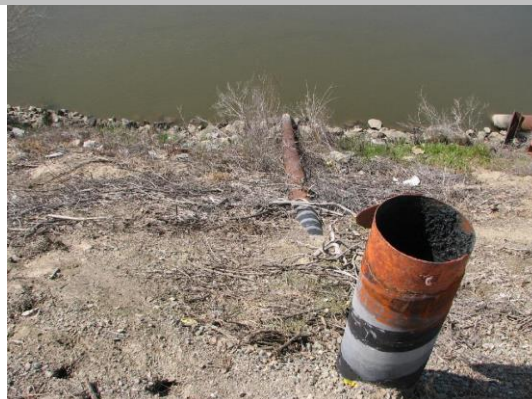
Photo 2 of 3 : UCIP_FA_2018_40672_72267.jpg

View of waterward side.

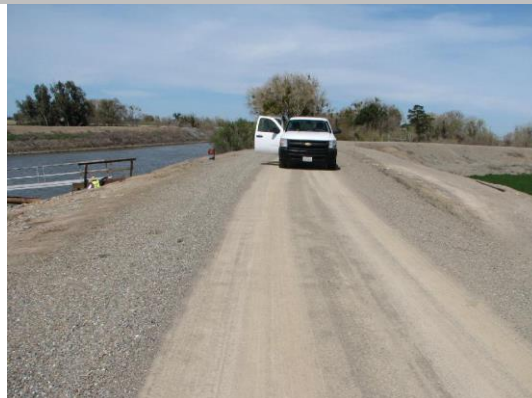
Photo 1 of 3 : UCIP_FA_2018_40677_72289.jpg

Comment Code						
Inspector Comment						
FS_ID:40677 DS_ID:40 EP_NO: 15123 Repair Type: Non-Urgent Crossing Status: Found UCIP Comments: Landowner mentioned power line was stolen crossing was non-functional during inspection. Potential erosion underneath walkway--need to confirm lose soil. Need to contact owner to determine status of crossing. If crossing is no longer used need to coordinate with CVFPB for proper abandonment. FIELD_STRUCT_DESC: 16-inch steel irrigation pipe through levee, 2.70 feet below the levee crown. Siphon breaker on waterside (WS) shoulder. Ramp on platform in channel, walkway from pump platform to WS slope, standpipe located at landside (LS) berm toe. (16-inch pipe installed and authorized under Permit No. 15123-1989, also includes removal of two existing pipes, 8-inch and 10-inch) [Additional Reference(s): DWR Levee Logs, 1981 and 2003] FS Date: 2/4/2010

View of levee crown at crossing.

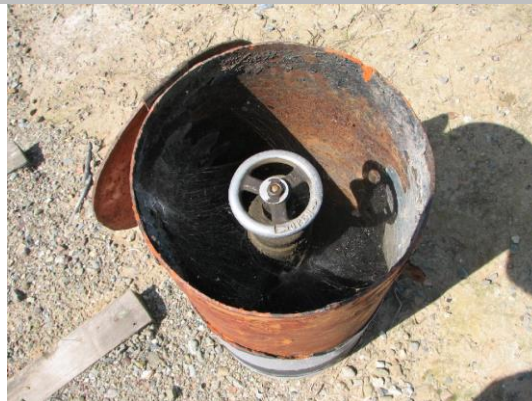
Photo 2 of 3 : UCIP_FA_2018_40677_72294.jpg

Siphon breaker located on waterward side.

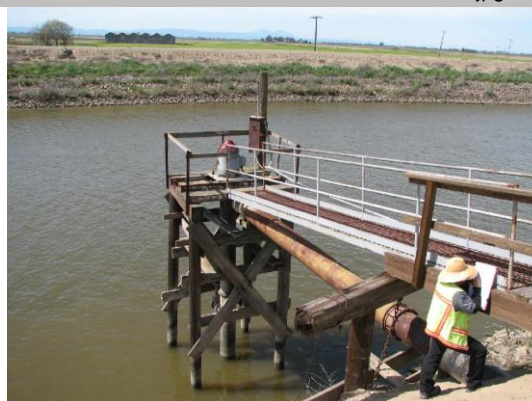
Photo 3 of 3 : UCIP_FA_2018_40677_72292.jpg

Comment Code						
Inspector Comment						
FS_ID:40677 DS_ID:40 EP_NO: 15123 Repair Type: Non-Urgent Crossing Status: Found UCIP Comments: Landowner mentioned power line was stolen crossing was non-functional during inspection. Potential erosion underneath walkway--need to confirm lose soil. Need to contact owner to determine status of crossing. If crossing is no longer used need to coordinate with CVFPB for proper abandonment. FIELD_STRUCT_DESC: 16-inch steel irrigation pipe through levee, 2.70 feet below the levee crown. Siphon breaker on waterside (WS) shoulder. Ramp on platform in channel, walkway from pump platform to WS slope, standpipe located at landside (LS) berm toe. (16-inch pipe installed and authorized under Permit No. 15123-1989, also includes removal of two existing pipes, 8-inch and 10-inch) [Additional Reference(s): DWR Levee Logs, 1981 and 2003] FS Date: 2/4/2010

View of waterward side.

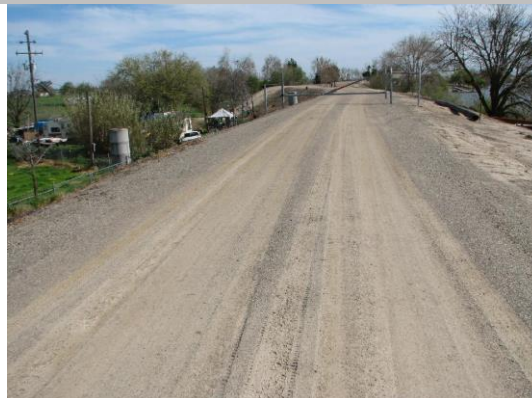
Photo 1 of 3 : UCIP_FA_2018_40679_72307.jpg

Comment Code						
Inspector Comment						
FS_ID:40679						
DS_ID:42						
EP_NO: 15077						
Repair Type: Non-Urgent						
Crossing Status: Found						
UCIP Comments: Surface erosion on waterward slope. Abandoned pipe section left on waterward slope. Need to contact owner to obtain additional information about crossing.						
FIELD_STRUCT_DESC: 12-inch steel irrigation pipe through levee. Invert of pipe 3.67 feet below levee crown. Siphon breaker on landside (LS) shoulder. Pump on platform in channel, walkway from pump platform to waterside (WS) shoulder. Standpipe located 15 feet from the LS toe. (12-inch pipe authorized under Permit No. 15077, 1989 - J. P. Leal, existing 12-inch pipe removed) [Additional Reference(s): DWR Levee Logs, 1981 and 2003, 12-inch pipe]						
FS Date: 2/4/2010

Overview of levee crown at crossing.

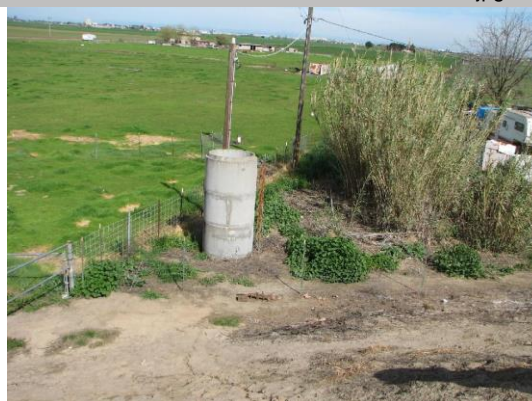
Photo 3 of 3 : UCIP_FA_2018_40679_72305.jpg

Comment Code						
Inspector Comment						
FS_ID:40679						
DS_ID:42						
EP_NO: 15077						
Repair Type: Non-Urgent						
Crossing Status: Found						
UCIP Comments: Surface erosion on waterward slope. Abandoned pipe section left on waterward slope. Need to contact owner to obtain additional information about crossing.						
FIELD_STRUCT_DESC: 12-inch steel irrigation pipe through levee. Invert of pipe 3.67 feet below levee crown. Siphon breaker on landside (LS) shoulder. Pump on platform in channel, walkway from pump platform to waterside (WS) shoulder. Standpipe located 15 feet from the LS toe. (12-inch pipe authorized under Permit No. 15077, 1989 - J. P. Leal, existing 12-inch pipe removed) [Additional Reference(s): DWR Levee Logs, 1981 and 2003, 12-inch pipe]						
FS Date: 2/4/2010

Standpipe visible on landward toe.

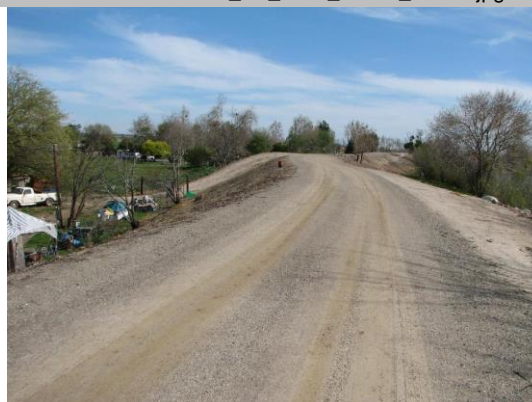
Photo 1 of 3 : UCIP_FA_2018_40680_72314.jpg

Comment Code						
Inspector Comment						
FS_ID:40680						
DS_ID:43						
EP_NO: 15078						
Repair Type: Non-Urgent						
Crossing Status: Found						
UCIP Comments: Crossing is non-functional recommend contacting owner to determine status of crossing. If crossing is no longer used need to coordinate with CVFPB for proper abandonment.						
FIELD_STRUCT_DESC: 4-inch irrigation pipe of unknown material through levee, 2.89 feet below levee crown. Siphon breaker on landside (LS) shoulder. Pump on waterside (WS) berm. (4-inch pipe authorized under Permit No. 15078, 1989 - S. and F. Aurelio, existing 4-inch pipe removed) [Additional Reference(s): DWR Levee Logs, 1981 and 2003]						
FS Date: 2/4/2010

Overview of levee crown at crossing.

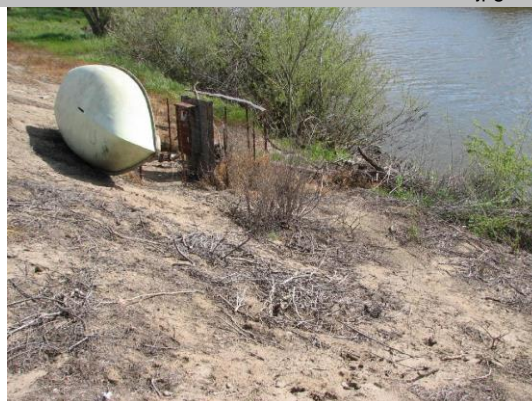
Photo 2 of 3 : UCIP_FA_2018_40680_72313.jpg

Comment Code						
Inspector Comment						
FS_ID:40680						
DS_ID:43						
EP_NO: 15078						
Repair Type: Non-Urgent						
Crossing Status: Found						
UCIP Comments: Crossing is non-functional recommend contacting owner to determine status of crossing. If crossing is no longer used need to coordinate with CVFPB for proper abandonment.						
FIELD_STRUCT_DESC: 4-inch irrigation pipe of unknown material through levee, 2.89 feet below levee crown. Siphon breaker on landside (LS) shoulder. Pump on waterside (WS) berm. (4-inch pipe authorized under Permit No. 15078, 1989 - S. and F. Aurelio, existing 4-inch pipe removed) [Additional Reference(s): DWR Levee Logs, 1981 and 2003]						
FS Date: 2/4/2010

Abandoned boat protecting pump station located on waterward side.

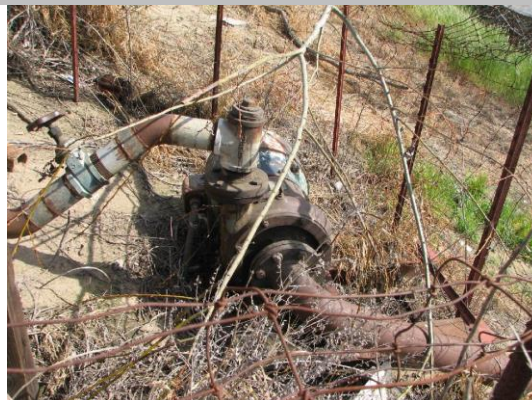
Photo 3 of 3 : UCIP_FA_2018_40680_72316.jpg

Motor located on waterward slope.

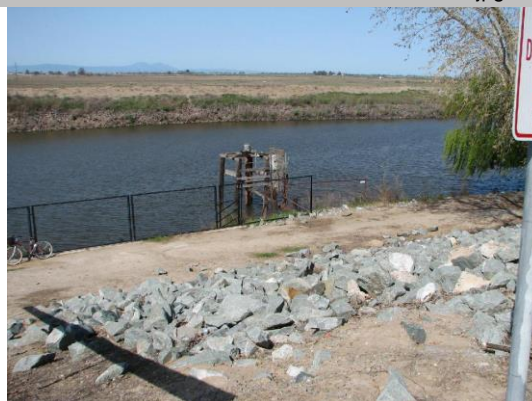
Photo 1 of 3 : UCIP_FA_2018_40681_72325.jpg

Comment Code					
Inspector Comment					
FS_ID:40681 DS_ID:44 EP_NO: 15079 Repair Type: Non-Urgent Crossing Status: Found UCIP Comments: If crossing is no longer in use owner will need to coordinate with DWR inspector and CVFPB to remove according to Title 23 requirements. Unable to determine if crossing is in use. FIELD_STRUCT_DESC: 14-inch steel irrigation pipe through levee, 1.17 feet below levee crown. Siphon breaker on waterside (WS) shoulder. Pump on platform in channel, walkway from pump platform to the top of the riverbank, standpipe located 12 feet from landside (LS) toe. (14-inch pipe installed under Permit No. 15079-1990 - San Joaquin County Parks and Joe P. Aven, authorized work also include installation of 10-inch pipe in general area and the removal of two existing pipes, 10-inch pipe and 6-inch pipe) [Additional Reference(s): DWR Levee Logs, 1981 and 2003] FS Date: 2/4/2010

View of waterward side.

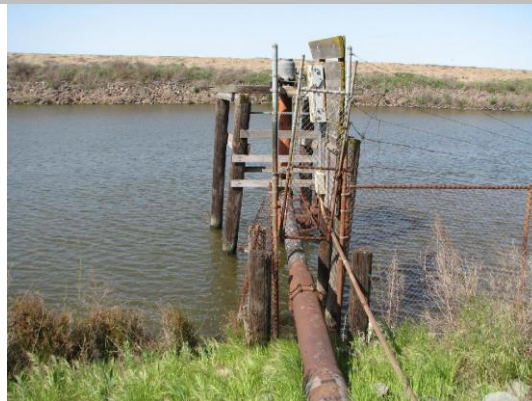
Photo 2 of 3 : UCIP_FA_2018_40681_72328.jpg

Pipe, pump, and platform located on waterward side.

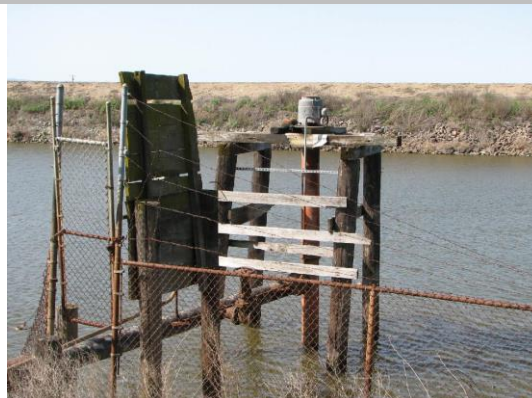
Photo 3 of 3 : UCIP_FA_2018_40681_72330.jpg

Comment Code						
Inspector Comment						
FS_ID:40681 DS_ID:44 EP_NO: 15079 Repair Type: Non-Urgent Crossing Status: Found UCIP Comments: If crossing is no longer in use owner will need to coordinate with DWR inspector and CVFPB to remove according to Title 23 requirements. Unable to determine if crossing is in use. FIELD_STRUCT_DESC: 14-inch steel irrigation pipe through levee, 1.17 feet below levee crown. Siphon breaker on waterside (WS) shoulder. Pump on platform in channel, walkway from pump platform to the top of the riverbank, standpipe located 12 feet from landside (LS) toe. (14-inch pipe installed under Permit No. 15079-1990 - San Joaquin County Parks and Joe P. Aven, authorized work also include installation of 10-inch pipe in general area and the removal of two existing pipes, 10-inch pipe and 6-inch pipe) [Additional Reference(s): DWR Levee Logs, 1981 and 2003] FS Date: 2/4/2010

Pump station fenced off on waterward side.

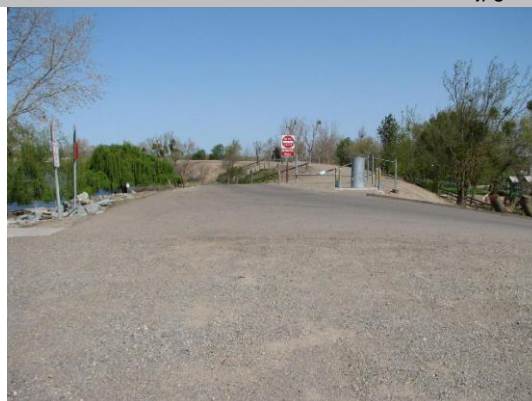
Photo 1 of 3 : UCIP_FA_2018_40682_72322.jpg

Comment Code						
Inspector Comment						
FS_ID:40682 DS_ID:99 EP_NO: 17643 Repair Type: Non-Urgent Crossing Status: Found UCIP Comments: Need to coordinate with owner to determine when the other 3 crossings will become online. FIELD_STRUCT_DESC: [Stonebridge Pump Station/Dos Reis Road Outfall Structure] 30-inch and 36-inch combination cement motar lined and coated steel drainage pipe through the levee, 2-feet below the levee crown. Concrete headwall on waterside (WS) toe and a 36-inch tidal flex valve on outlet of pipe. 36-inch pipe section starts at WS headwall and is reduced with a 30-inch pipe on WS. The 30-inch pipe continues through from WS to LS levee. Structure was designed for 5 crossings however only 1 crossing is active (30-inch pipe and 36-inch combination pipe through the levee authorized under Permit No. 17643, 2005 - City of Lathrop, structure can accommodate five 36-inch pipes discharge pipes - only one 36-inch pipe active). FS Date: 2/4/2010

Overview of levee crown at crossing.

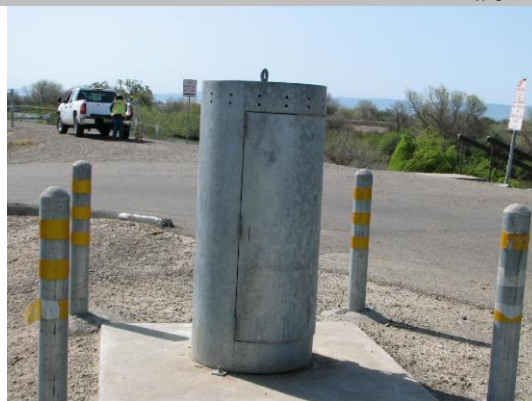
Photo 2 of 3 : UCIP_FA_2018_40682_72321.jpg

Relief valve located on landward shoulder.

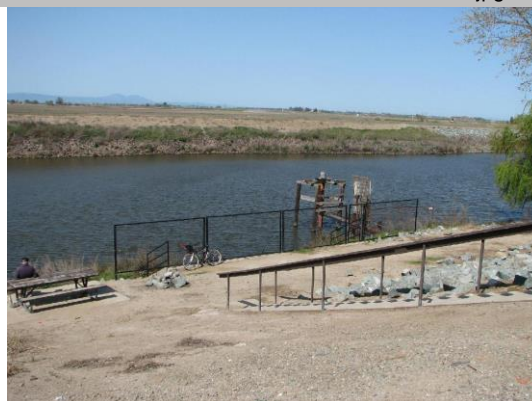
Photo 3 of 3 : UCIP_FA_2018_40682_72320.jpg

Comment Code						
Inspector Comment						
FS_ID:40682 DS_ID:99 EP_NO: 17643 Repair Type: Non-Urgent Crossing Status: Found UCIP Comments: Need to coordinate with owner to determine when the other 3 crossings will become online. FIELD_STRUCT_DESC: [Stonebridge Pump Station/Dos Reis Road Outfall Structure] 30-inch and 36-inch combination cement motar lined and coated steel drainage pipe through the levee, 2-feet below the levee crown. Concrete headwall on waterside (WS) toe and a 36-inch tidal flex valve on outlet of pipe. 36-inch pipe section starts at WS headwall and is reduced with a 30-inch pipe on WS. The 30-inch pipe continues through from WS to LS levee. Structure was designed for 5 crossings however only 1 crossing is active (30-inch pipe and 36-inch combination pipe through the levee authorized under Permit No. 17643, 2005 - City of Lathrop, structure can accommodate five 36-inch pipes discharge pipes - only one 36-inch pipe active). FS Date: 2/4/2010

View of waterward side.

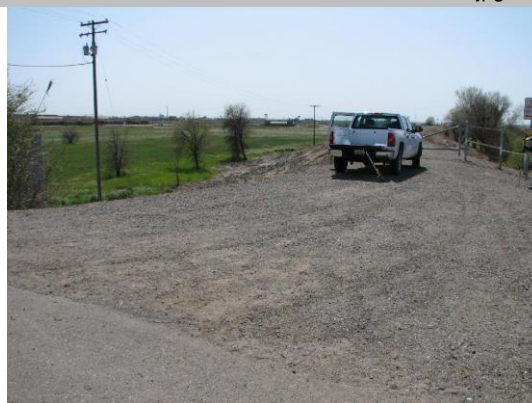
Photo 1 of 3 : UCIP_FA_2018_40683_72333.jpg

LM Start	7.45	Rating **	M	Issue No.	120
LM End	7.45	Issue Type +	En	Location *	
Category	Supplemental			GPS Latitude/Longitude	
				Start	End
Item	DWR UCIP Field Study			37.829922 °	37.829922 °
				-121.310865 °	-121.310865 °
DWR ID	284				
Comment Code					
Inspector Comment					
FS_ID:40683					
DS_ID:284					
EP_NO: 15079					
Repair Type: Non-Urgent					
Crossing Status: Found					
UCIP Comments: Potential leak at standpipe--unable to confirm if crossing is operable. If crossing is no longer in use owner will need to coordinate with DWR inspector and CVFPB to remove according to Title 23 requirements. Unable to determine if crossing is in use.					
FIELD_STRUCT_DESC: 2 of 2. 10 inch pipe also referenced as 478+22, old 6 inch pipe was removed per encroachment recordation.					
FS Date: 2/4/2010

Overview of levee crown at crossing.

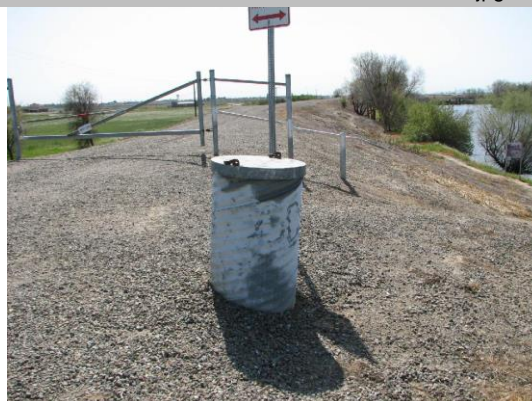
Photo 2 of 3 : UCIP_FA_2018_40683_72332.jpg

FS_ID:40683
DS_ID:284
EP_NO: 15079
Repair Type: Non-Urgent
Crossing Status: Found
UCIP Comments: Potential leak at standpipe--unable to confirm if crossing is operable. If crossing is no longer in use owner will need to coordinate with DWR inspector and CVFPB to remove according to Title 23 requirements. Unable to determine if crossing is in use.
FIELD_STRUCT_DESC: 2 of 2. 10 inch pipe also referenced as 478+22, old 6 inch pipe was removed per encroachment recordation.
FS Date: 2/4/2010

CMP riser located on waterward shoulder.

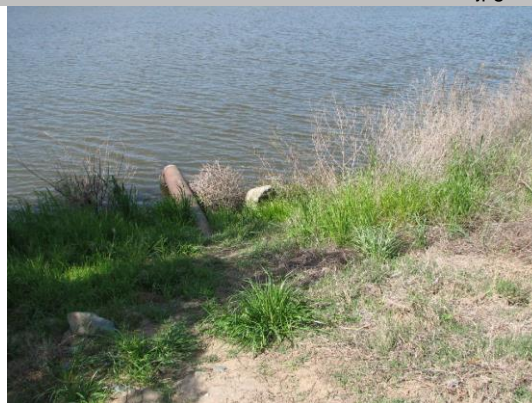
Photo 3 of 3 : UCIP_FA_2018_40683_72335.jpg

Pipe visible on waterward side.

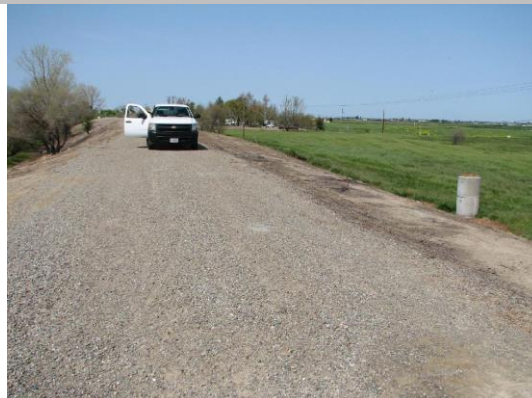
Photo 1 of 3 : UCIP_FA_2018_40684_72340.jpg

Comment Code						
Inspector Comment						
FS_ID:40684 DS_ID:97 EP_NO: 15080 Repair Type: Non-Urgent Crossing Status: Found UCIP Comments: Pipe appears no longer in use. If crossing is no longer in use owner will need to coordinate with DWR inspector and CVFPB to remove according to Title 23 requirements. Unable to determine if crossing is in use. FIELD_STRUCT_DESC: 6-inch steel irrigation pipe through the levee, 4.43-feet below crown. Pump on waterside (WS) slope, siphon breaker on WS shoulder, and standpipe on landside (LS) toe. (7-inch pipe installed and was authorized under Permit No. 15080, 1989 - J. P. Aven, existing 6-inch pipe removed). FS Date: 2/4/2010

Overview of levee crown at crossing.

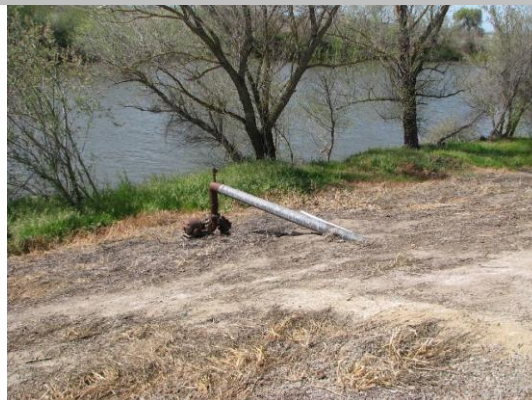
Photo 2 of 3 : UCIP_FA_2018_40684_72342.jpg

View of waterward side.

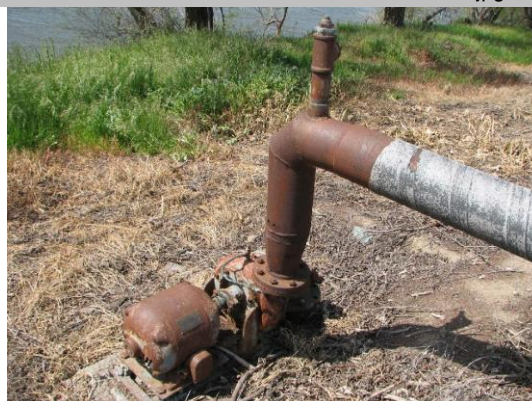
Photo 3 of 3 : UCIP_FA_2018_40684_72338.jpg

Comment Code						
Inspector Comment						
FS_ID:40684						
DS_ID:97						
EP_NO: 15080						
Repair Type: Non-Urgent						
Crossing Status: Found						
UCIP Comments: Pipe appears no longer in use. If crossing is no longer in use owner will need to coordinate with DWR inspector and CVFPB to remove according to Title 23 requirements. Unable to determine if crossing is in use.						
FIELD_STRUCT_DESC: 6-inch steel irrigation pipe through the levee, 4.43-feet below crown. Pump on waterside (WS) slope, siphon breaker on WS shoulder, and standpipe on landside (LS) toe. (7-inch pipe installed and was authorized under Permit No. 15080, 1989 - J. P. Aven, existing 6-inch pipe removed).						
FS Date: 2/4/2010

Pump and pipe located on waterward slope.

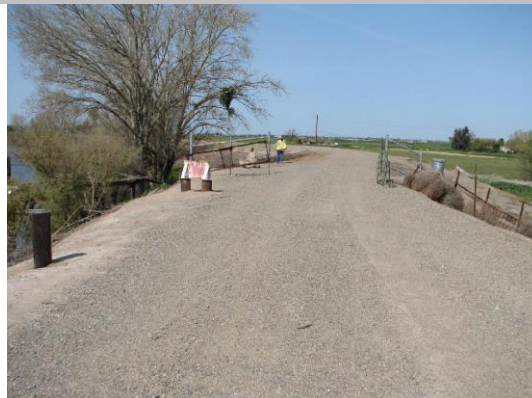
Photo 1 of 3 : UCIP_FA_2018_40685_72351.jpg

LM Start	7.71	Rating **	M	Issue No.	122
LM End	7.71	Issue Type +	En	Location *	
Category	Supplemental			GPS Latitude/Longitude	
				Start	End
Item	DWR UCIP Field Study			37.826333 °	37.826333 °
				-121.309495 °	-121.309495 °
DWR ID	98				
Comment Code					
Inspector Comment					
FS_ID:40685 DS_ID:98 EP_NO: 15081 Repair Type: Non-Urgent Crossing Status: Found UCIP Comments: Erosion present on waterward toe underneath piles. Need to coordinate with owner to address issue on waterward side and to determine status of crossing. FIELD_STRUCT_DESC: 16-inch asphalt coated and wrapped steel irrigation pipe through the levee, 2.6-feet below the crown. Siphon breaker located on landside (LS). Stand pipe located at LS toe. Pump on Platform at waterside (WS) toe. (16-inch pipe installed under Permit No. 15081, 1989 - I. N. Robinson, Jr., existing 14-inch pipe removed) FS Date: 2/4/2010

Overview of levee crown at pipe crossing.

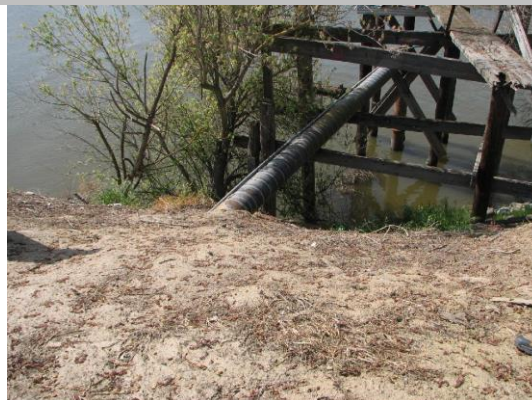
Photo 2 of 3 : UCIP_FA_2018_40685_72350.jpg

Pipe daylight on waterward side.

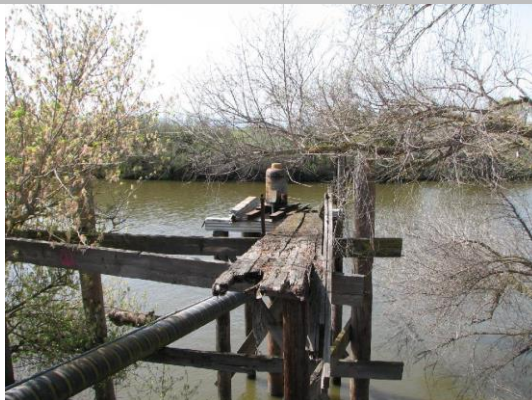
Photo 3 of 3 : UCIP_FA_2018_40685_72348.jpg

Comment Code						
Inspector Comment						
FS_ID:40685 DS_ID:98 EP_NO: 15081 Repair Type: Non-Urgent Crossing Status: Found UCIP Comments: Erosion present on waterward toe underneath piles. Need to coordinate with owner to address issue on waterward side and to determine status of crossing. FIELD_STRUCT_DESC: 16-inch asphalt coated and wrapped steel irrigation pipe through the levee, 2.6-feet below the crown. Siphon breaker located on landside (LS). Stand pipe located at LS toe. Pump on Platform at waterside (WS) toe. (16-inch pipe installed under Permit No. 15081, 1989 - I. N. Robinson, Jr., existing 14-inch pipe removed) FS Date: 2/4/2010

Pump station located on platform located on waterward side.

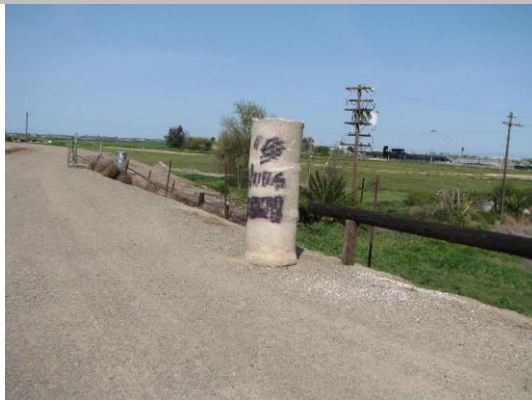
Photo 1 of 2 : UCIP_FA_2018_40686_72353.jpg

LM Start	7.73	Rating **	M	Issue No.	123
LM End	7.73	Issue Type +	En	Location *	
Category	Supplemental			GPS Latitude/Longitude	
				Start	End
Item	DWR UCIP Field Study			37.826031 °	37.826031 °
				-121.309569 °	-121.309569 °
DWR ID	804				
Comment Code					
Inspector Comment					
FS_ID:40686 DS_ID:804 EP_NO: N/A Repair Type: Non-Urgent Crossing Status: Indicator Found UCIP Comments: Unable to find any appurtenances need to coordinate with owner to obtain additional information about crossing. Standpipe appears abandoned. If crossing is no longer in use owner will need to coordinate with DWR inspector and CVFPB to remove according to Title 23 requirements. Unable to determine if crossing is in use. FIELD_STRUCT_DESC: Standpipe located on levee crown. FS Date: 2/4/2010

Standpipe located on levee crown.

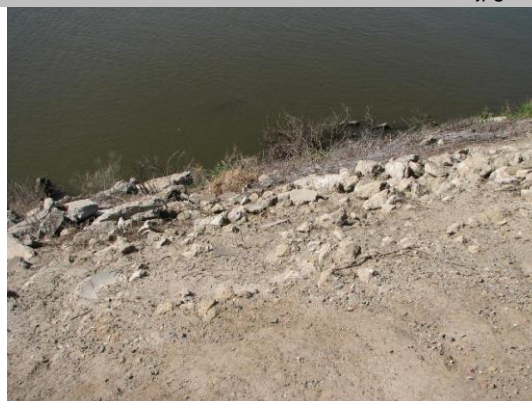
Photo 2 of 2 : UCIP_FA_2018_40686_72352.jpg

LM Start	7.73	Rating **	M	Issue No.	123 (cont)	
LM End	7.73	Issue Type +	En	Location *		
Category	Supplemental			GPS Latitude/Longitude		
				Start	End	
Item	DWR UCIP Field Study			37.826031 °	37.826031 °	
				-121.309569 °	-121.309569 °	
DWR ID	804					
Comment Code						
Inspector Comment						
FS_ID:40686						
DS_ID:804						
EP_NO: N/A						
Repair Type: Non-Urgent						
Crossing Status: Indicator Found						
UCIP Comments: Unable to find any appurtenances need to coordinate with owner to obtain additional information about crossing. Standpipe appears abandoned. If crossing is no longer in use owner will need to coordinate with DWR inspector and CVFPB to remove according to Title 23 requirements. Unable to determine if crossing is in use.						
FIELD_STRUCT_DESC: Standpipe located on levee crown.						
FS Date: 2/4/2010

View of waterward side.

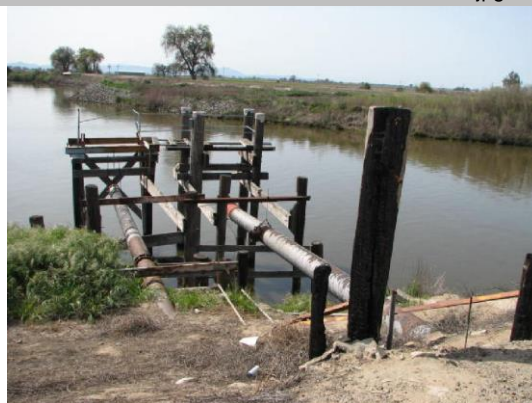
Photo 1 of 3 : UCIP_FA_2018_40687_72357.jpg

Comment Code						
Inspector Comment						
FS_ID:40687 DS_ID:100 EP_NO: 15082 Repair Type: Non-Urgent Crossing Status: Found UCIP Comments: Pumps were removed and no power connection visible. Crossing appears abandoned. If crossing is no longer in use owner will need to coordinate with DWR inspector and CVFPB to remove according to Title 23 requirements. Unable to determine if crossing is in use. FIELD_STRUCT_DESC: 20-inch asphalt coated and wrapped steel irrigation pipe through levee, 2.1-feet below the crown. Pump missing from platform on waterside (WS). Siphon breaker inside 24-inch corrugated metal pipe (CMP) riser on landside (LS) shoulder. (20-inch pipe installed under Permit No. 15082, 1989 - I. N. Robinson, Jr., also authorized under permit two existing 14-inch pipes removed and installation of 16-inch pipe in general area) FS Date: 2/4/2010

View of waterward side.

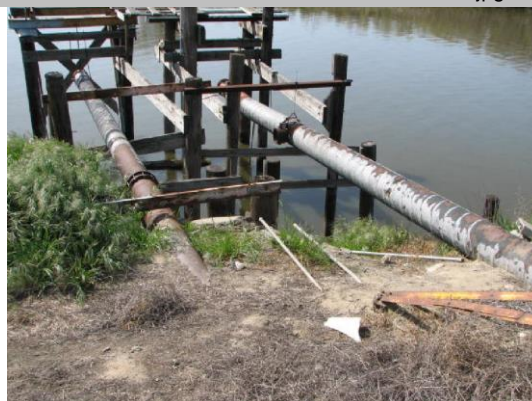
Photo 2 of 3 : UCIP_FA_2018_40687_72356.jpg

Comment Code						
Inspector Comment						
FS_ID:40687 DS_ID:100 EP_NO: 15082 Repair Type: Non-Urgent Crossing Status: Found UCIP Comments: Pumps were removed and no power connection visible. Crossing appears abandoned. If crossing is no longer in use owner will need to coordinate with DWR inspector and CVFPB to remove according to Title 23 requirements. Unable to determine if crossing is in use. FIELD_STRUCT_DESC: 20-inch asphalt coated and wrapped steel irrigation pipe through levee, 2.1-feet below the crown. Pump missing from platform on waterside (WS). Siphon breaker inside 24-inch corrugated metal pipe (CMP) riser on landside (LS) shoulder. (20-inch pipe installed under Permit No. 15082, 1989 - I. N. Robinson, Jr., also authorized under permit two existing 14-inch pipes removed and installation of 16-inch pipe in general area) FS Date: 2/4/2010

View of waterward side--no pumps present anymore.

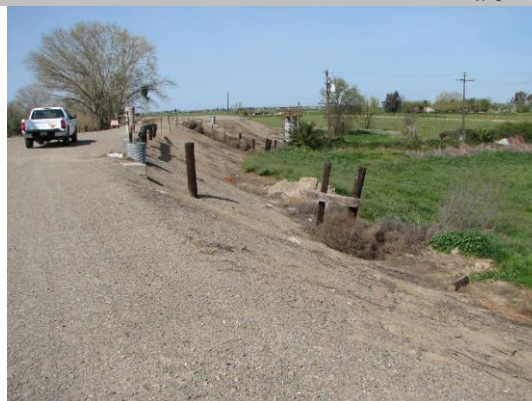
Photo 2 of 3 : UCIP_FA_2018_40688_72360.jpg

Comment Code						
Inspector Comment						
FS_ID:40688 DS_ID:288 EP_NO: 15082 Repair Type: Non-Urgent Crossing Status: Found UCIP Comments: Pump was removed and no power connection visible. Crossing appears abandoned. If crossing is no longer in use owner will need to coordinate with DWR inspector and CVFPB to remove according to Title 23 requirements. Unable to determine if crossing is in use. FIELD_STRUCT_DESC: 16- inch asphalt coated and wrapped steel irrigation pipe through levee, 2.6-feet below the crown. Pump missing from platform on waterside (WS). Siphon breaker inside 24-inch corrugated metal pipe (CMP) riser on landside (LS) shoulder. 1.5-inch galvanized iron electrical conduit at same location. (16-inch pipe installed under Permit No. 15082, 1989 - I. N. Robinson, Jr., also authorized under permit two existing 14-inch pipes removed and installation of 20-inch pipe in general area) FS Date: 2/4/2010

View of landward side.

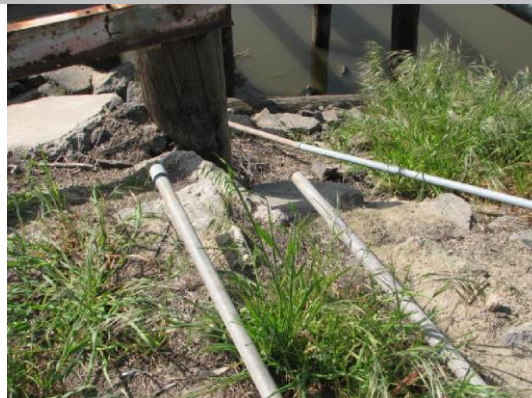
Photo 3 of 3 : UCIP_FA_2018_40688_72359.jpg

Comment Code						
Inspector Comment						
FS_ID:40688 DS_ID:288 EP_NO: 15082 Repair Type: Non-Urgent Crossing Status: Found UCIP Comments: Pump was removed and no power connection visible. Crossing appears abandoned. If crossing is no longer in use owner will need to coordinate with DWR inspector and CVFPB to remove according to Title 23 requirements. Unable to determine if crossing is in use. FIELD_STRUCT_DESC: 16- inch asphalt coated and wrapped steel irrigation pipe through levee, 2.6-feet below the crown. Pump missing from platform on waterside (WS). Siphon breaker inside 24-inch corrugated metal pipe (CMP) riser on landside (LS) shoulder. 1.5-inch galvanized iron electrical conduit at same location. (16-inch pipe installed under Permit No. 15082, 1989 - I. N. Robinson, Jr., also authorized under permit two existing 14-inch pipes removed and installation of 20-inch pipe in general area) FS Date: 2/4/2010

Conduits visible on waterward side--no connection.

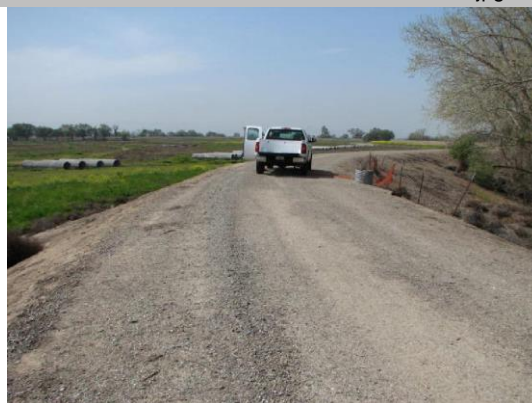
Photo 1 of 3 : UCIP_FA_2018_40689_72367.jpg

LM Start	7.89	Rating **	M	Issue No.	126
LM End	7.89	Issue Type +	En	Location *	
Category	Supplemental			GPS Latitude/Longitude	
				Start	End
Item	DWR UCIP Field Study			37.823987 °	37.823987 °
				-121.309841 °	-121.309841 °
DWR ID	805				
Comment Code					
Inspector Comment					
FS_ID:40689					
DS_ID:805					
EP_NO: N/A					
Repair Type: Non-Urgent					
Crossing Status: Indicator Found					
UCIP Comments: Only siphon breakers were found on landward shoulder no other appurtenances were found. If crossing is no longer in use owner will need to coordinate with DWR inspector and CVFPB to remove according to Title 23 requirements. Unable to determine if crossing is in use.					
FIELD_STRUCT_DESC: Siphon breaker located on landward shoulder.					
FS Date: 2/4/2010

View of levee crown at crossing.

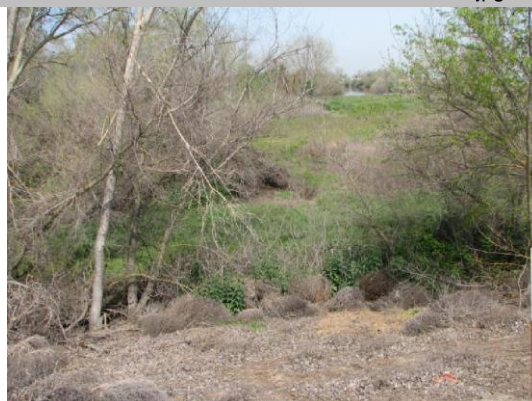
Photo 2 of 3 : UCIP_FA_2018_40689_72366.jpg

FS_ID:40689
DS_ID:805
EP_NO: N/A
Repair Type: Non-Urgent
Crossing Status: Indicator Found
UCIP Comments: Only siphon breakers were found on landward shoulder no other appurtenances were found. If crossing is no longer in use owner will need to coordinate with DWR inspector and CVFPB to remove according to Title 23 requirements. Unable to determine if crossing is in use.
FIELD_STRUCT_DESC: Siphon breaker located on landward shoulder.
FS Date: 2/4/2010

View of landward side.
